Post-war Bungalows (1945-1960s)

This brochure is one of a series of Housing Style Information Brochures based on the common housing styles in the Town of Vincent. The brochure provides details on the origins and distinct features of the housing types within Vincent. Other brochures in this series include: ■ Late Colonial Georgian Dwellings ■ Weatherboard Dwellings ■ Federation Bungalows ■ Inter-war Californian Bungalows

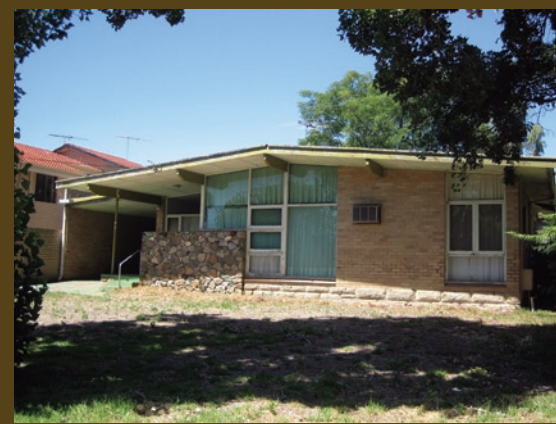
This brochure assists residents in understanding the Conventional Suburban Bungalow.

- Hipped/gabled roofs with a low-lying gable of around 30 degrees.
- Flat roofs introduced in more contemporary designs.
- Marseilles pattern tiles in conservative designs.
- Plain brick walls and chimneys with minimal exterior decorative elements.
- Asbestos cement sheeting for lining interior walls and ceilings.
- Double- or triple-room frontages.
- Plain timber or aluminium windows.
- Prominent window-walls.
